HIGH VOLTAGE SHUNT CAPACITOR BANKS

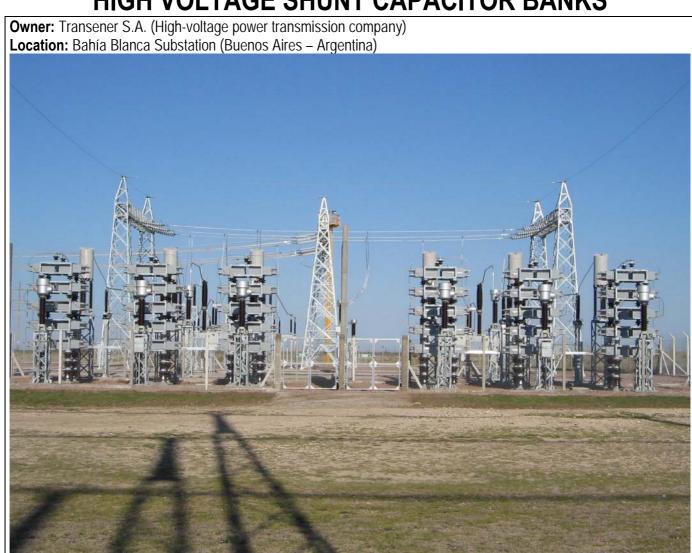
Description: Two 50MVAr – 132kV – 50Hz shunt capacitor banks in bridge connection, including inrush current limiting air-core reactors, unbalance protection, control and protection relay panels.

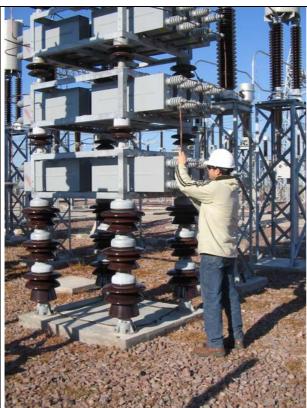
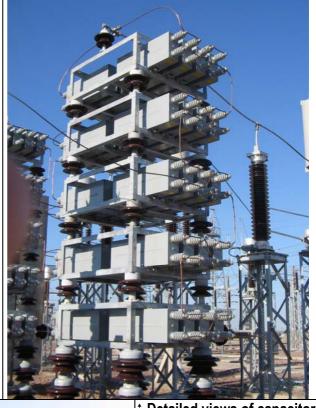
- ↑ Detailed views of capacitor bank:
- 1- During mounting
 2: Finished capacitor assembly

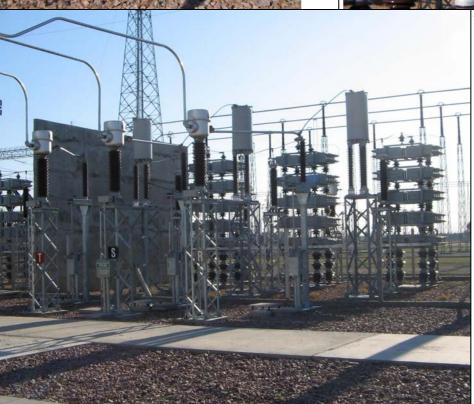
← View of line CTs.

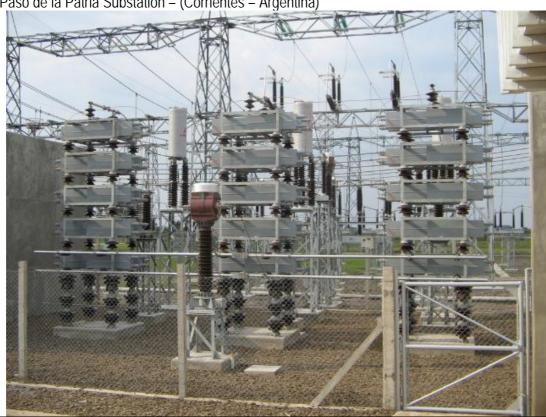
Description: Two 30MVAr – 138kV – 50Hz shunt capacitor banks in double-wye connection, including inrush current limiting air-core reactors, unbalance protection, control and protection relay panels.

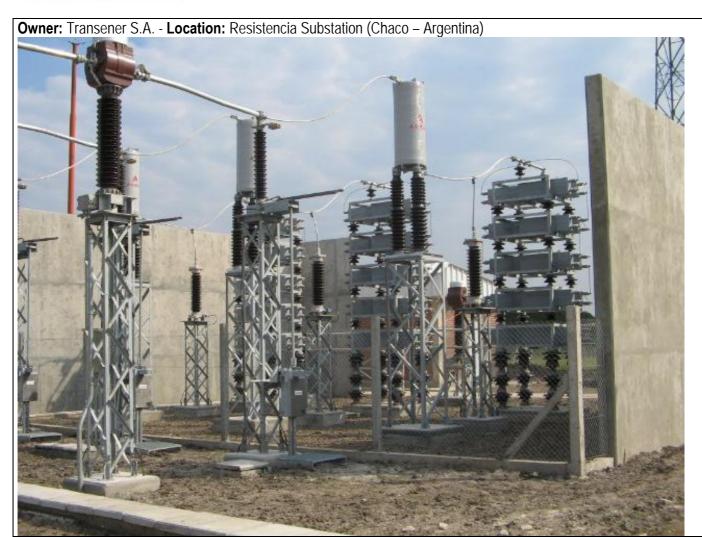
Description: Four 27.5MVAr – 145kV – 50Hz shunt capacitor banks in double-wye connection, including inrush current limiting air-core reactors, unbalance protection, control and protection relay panels.

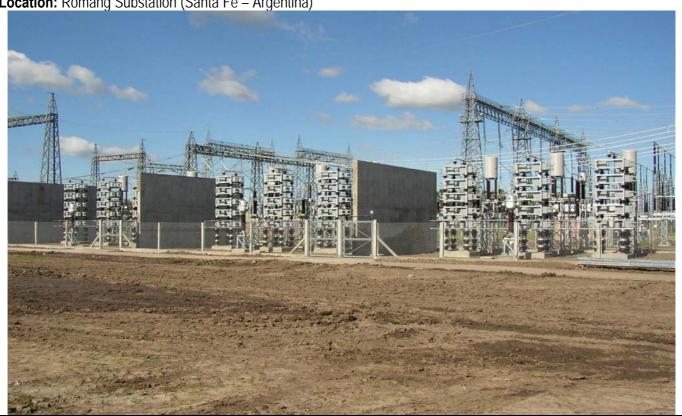
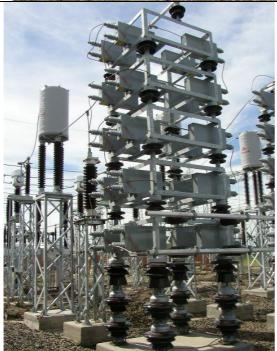
Description: Three 15MVAr - 132kV - 50Hz shunt capacitor banks in double-wye connection, including inrush current limiting air-core reactors, unbalance protection, control and protection relay panels.

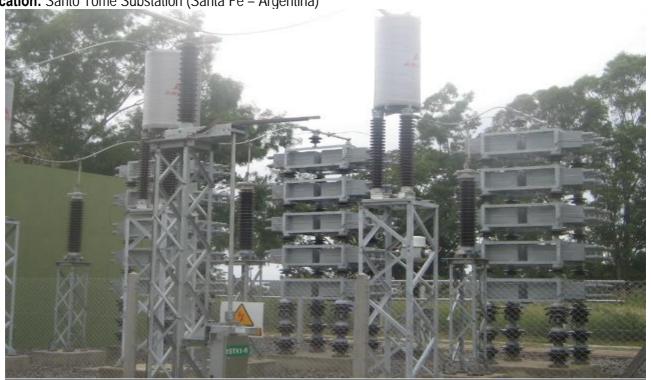
One 50MVAr – 132kV – 50Hz shunt capacitor bank in double-wye connection, including inrush current limiting air-core reactors, unbalance protection, protection relay panels.
